## SERVICE BULLETIN

**ID NUMBER & REVISION:** SB-022323-C

**SUBJECT:** Throttle Cable Chafing

**AIRCRAFT Affected:** **MAKE & MODEL:** ICON A5

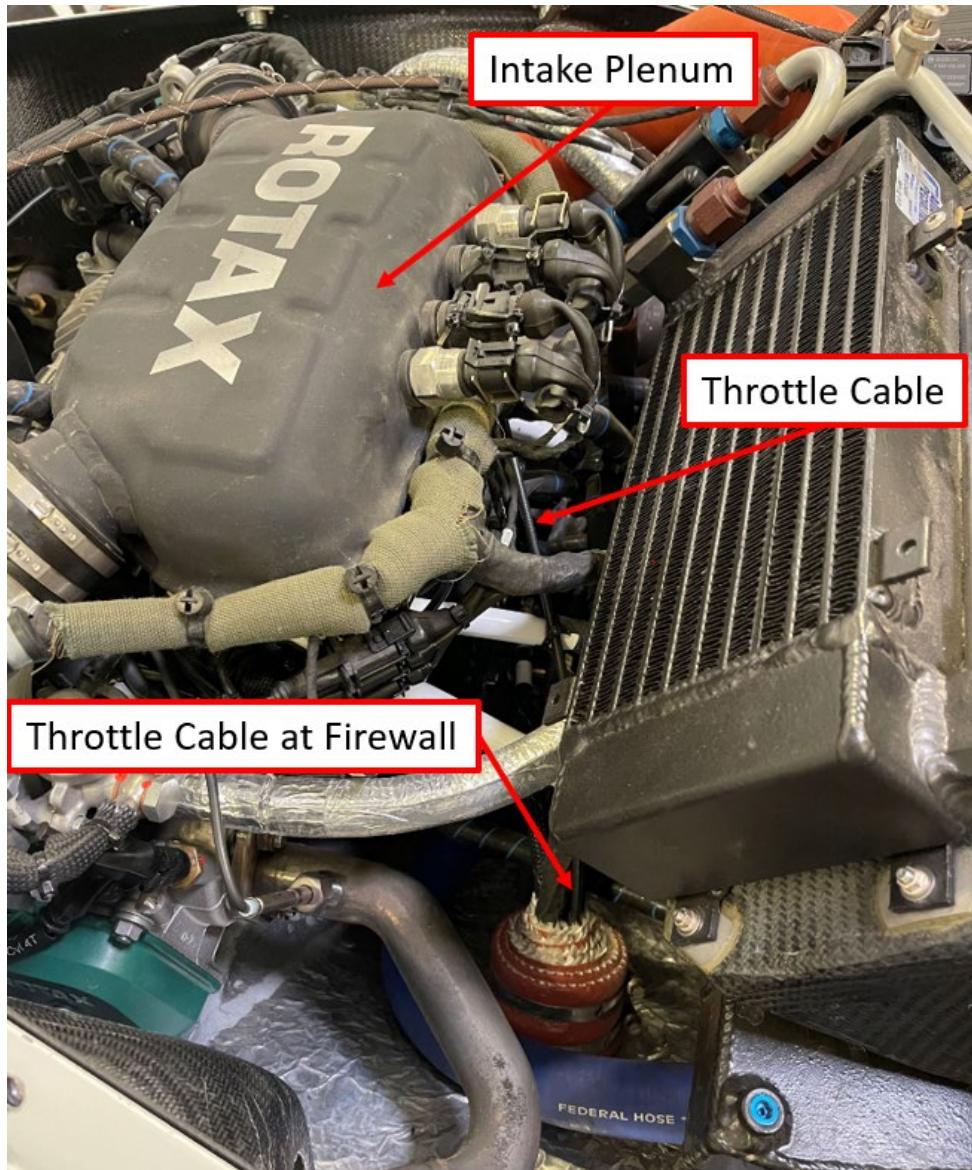
Figure 1 Throttle Cable Location

1. Remove the engine cowling.
  - a. ICON Aircraft Maintenance Manual: Remove Engine Cowlings ([100497](#)).
2. Locate the throttle cable at the lower intake plenum mount.
  - a. See Figures 1 and 2.

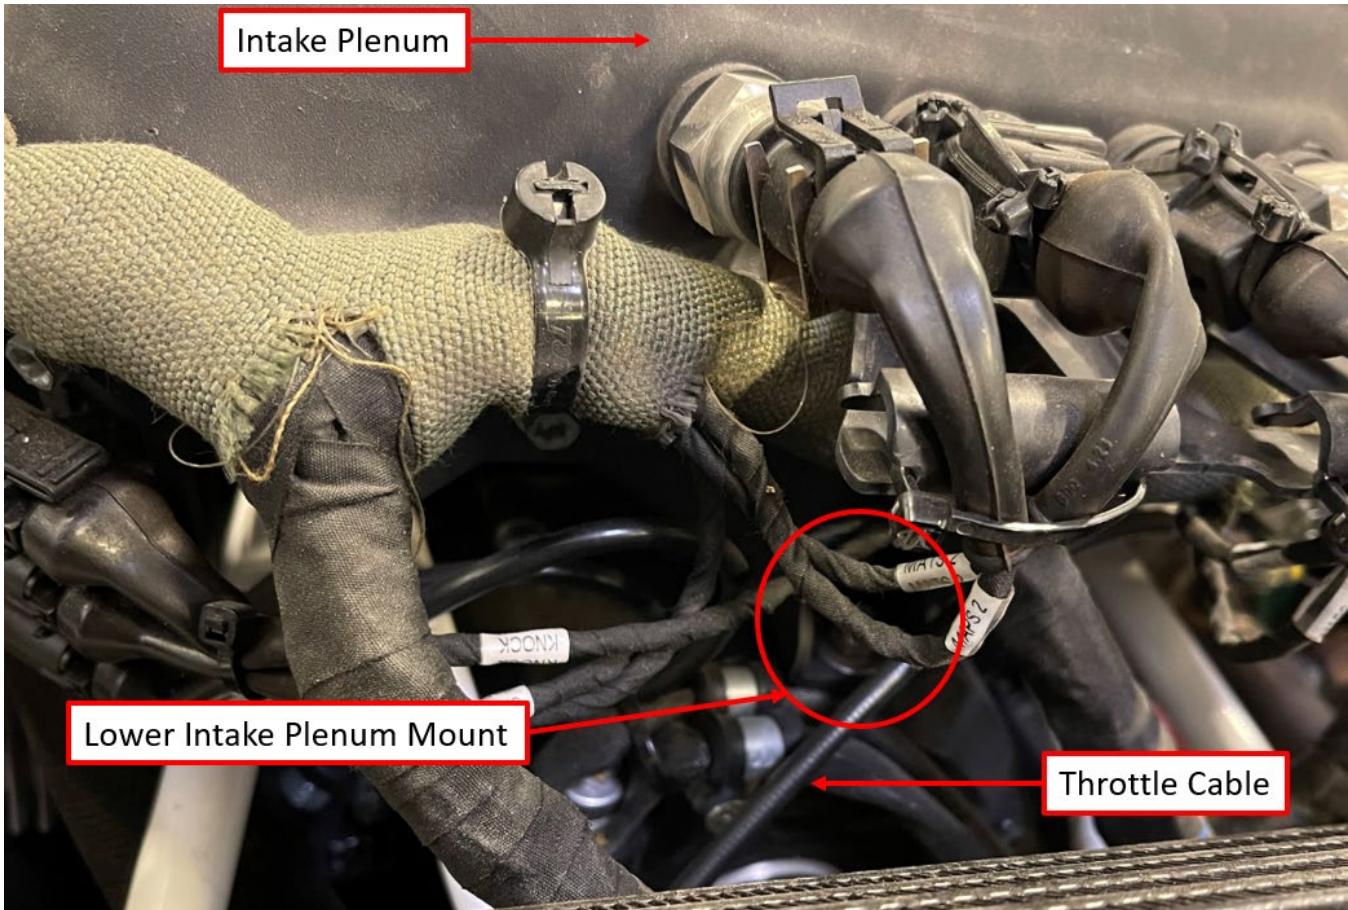
Figure 2 Throttle Cable at Lower Intake Plenum Mount

It has been identified that the throttle cable has been mounted on the engine in such a way that there will be little to no clearance between the throttle cable and lower intake plenum mount. The lack of proper clearance can cause the cable to chafe and potentially become damaged. Sustained damage to the throttle cable could lead to throttle cable failure and the inability of the pilot to control engine power. In addition, where the throttle cable is secured to the engine, chafing can occur if not properly secured.

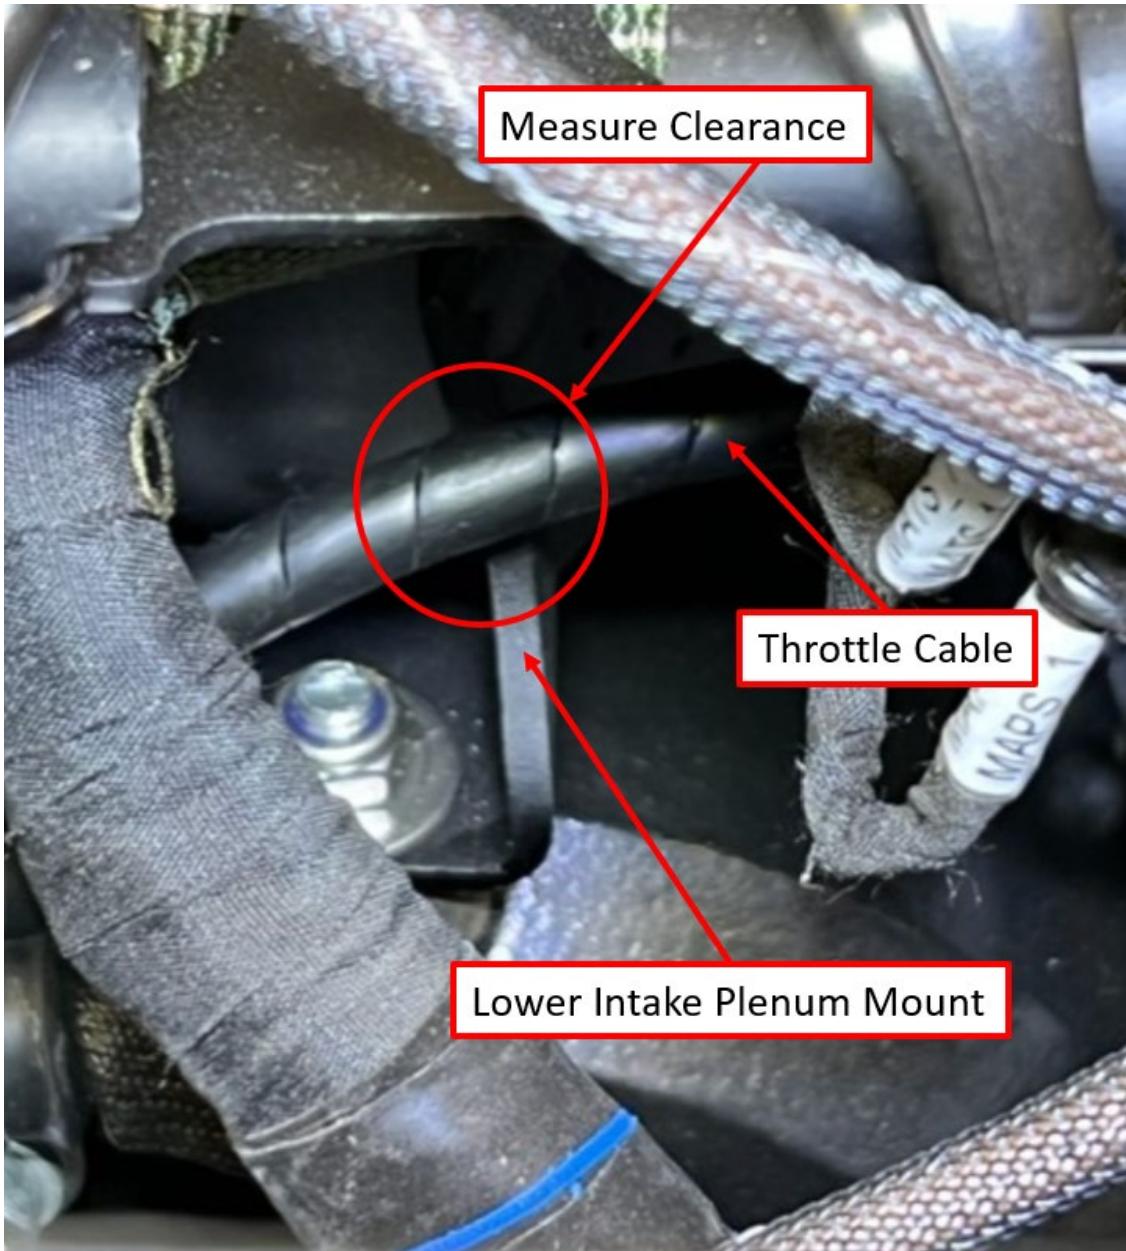
*Figure 3 Clearance at the Intake Plenum Mount***Repair**

3. Measure the clearance between the throttle cable and the lower intake plenum mount.
  - a. There should be a minimum of  $\frac{1}{4}$ " clearance.
  - b. See Figure 3.
4. Verify that there are two cable ties securing the throttle cable to the engine mount.
  - a. See Figure 5.
5. If there is less than  $\frac{1}{4}$ " clearance between the throttle cable and lower intake plenum mount *or* only **one** cable tie is securing the throttle cable to the engine mount, then proceed to the "Repair" section of this service bulletin.
6. If there is a  $\frac{1}{4}$ " or greater clearance between the throttle cable and lower intake plenum mount *and* **two** cable ties securing the throttle cable to the engine mount, then proceed to the "Logbook Entry" section of this service bulletin.

2. Verify F4 Tape is installed on the engine mount where the throttle cable is intended to be secured.
  - a. Install F4 tape if there is none where the throttle cable is intended to be secured.
3. Re-locate the throttle cable, along the engine mount, until a  $\frac{1}{4}$ " or greater clearance is achieved between the throttle cable and lower intake plenum mount.
4. Ensure that the throttle cable remains over the F4 tape on the engine mount.

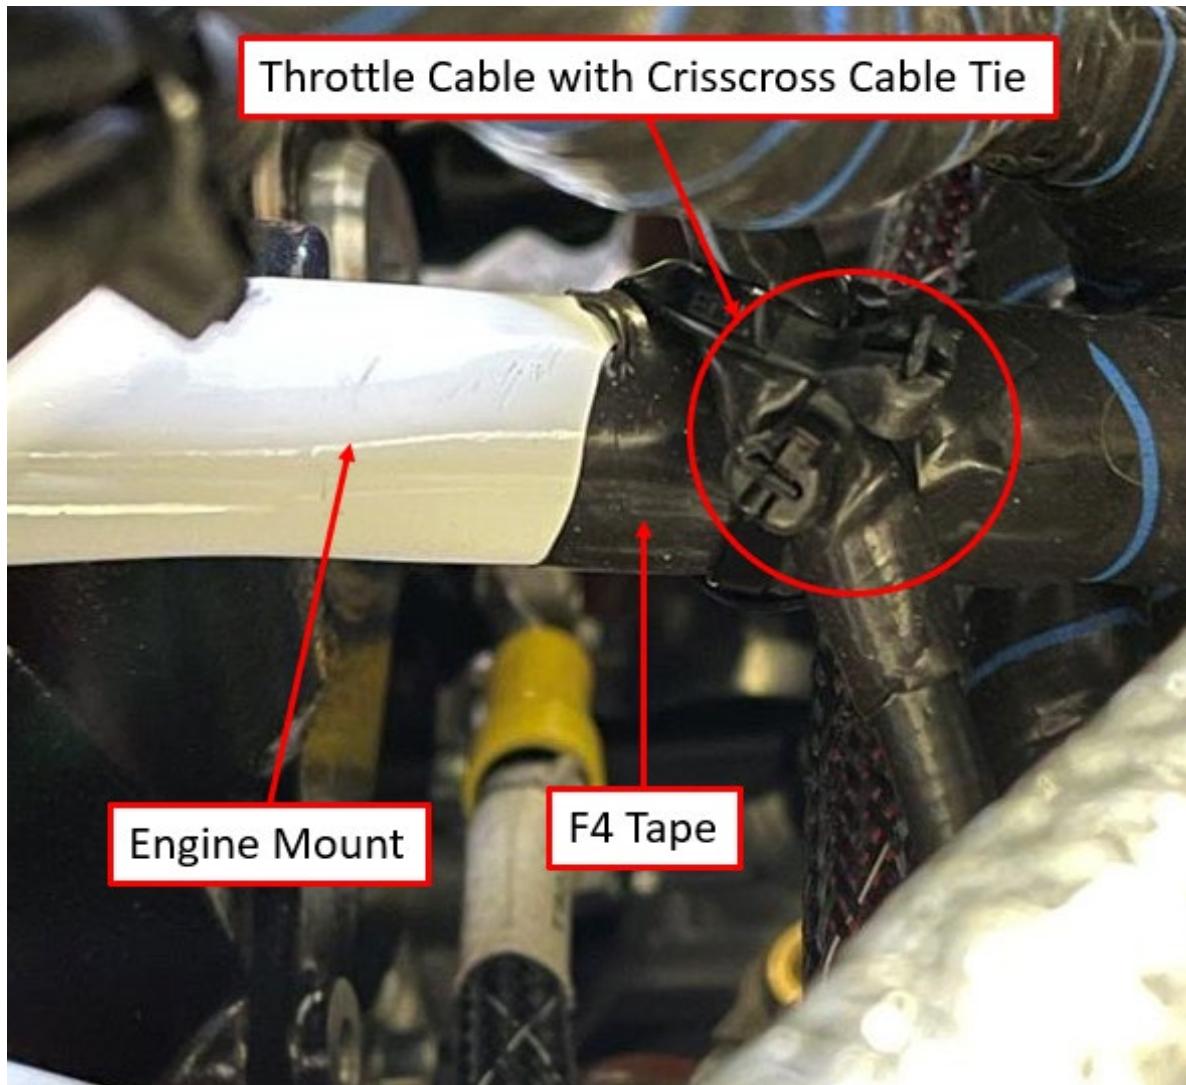
*Figure 5 Two Throttle Cable Ties at Engine Mount*

**NOTE:** There must be **two** cable ties securing the throttle cable to the engine mount. If there is a  $\frac{1}{4}$ " or greater clearance and only one cable tie securing the throttle cable to the engine mount, then another cable tie must be installed as shown in Figure 5.

5. Install F4 tape onto the throttle cable where the throttle cable will be secured to the engine mount.
6. Tightly secure the repositioned F4 wrapped throttle cable onto the F4 wrapped engine mount with two TY24MX cable ties in a crisscross pattern.
  - a. See Figure 5.
