SERVICE BULLETIN

ID NUMBER & REVISION: SB-060225-B

SUBJECT: (MANDATORY) E-Props 4-Blade Propeller Spinner Torque

AIRCRAFT AFFECTED: **MAKE & MODEL:** ICON A5

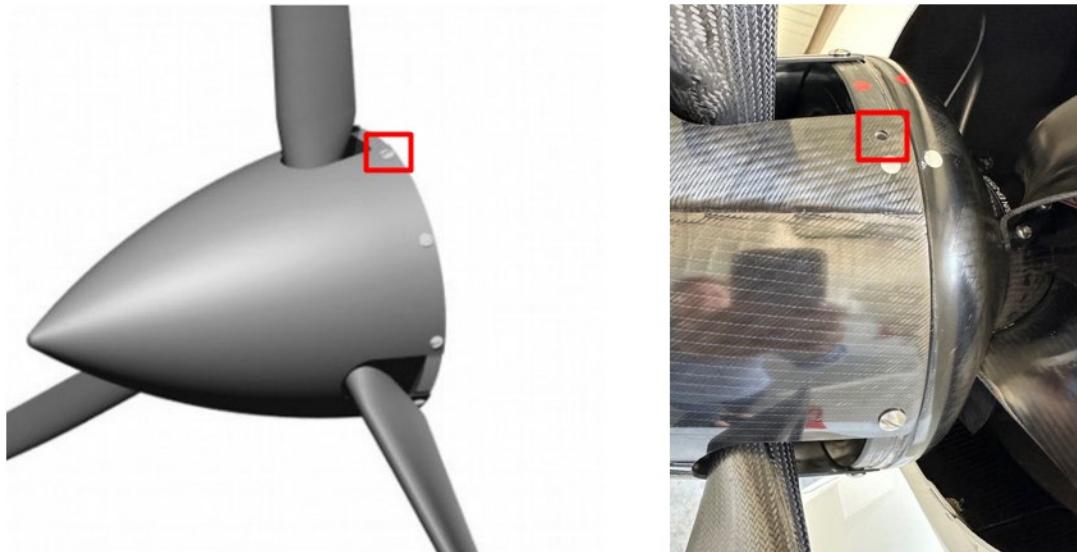
Due to a mistake in the installation manual, the Spinner on the E-Props 4-Blade Propeller may have been torqued incorrectly. In order to prevent damage to the propeller or aircraft body, the loose hardware must be properly installed.

Figure 1. Spinner Screws, 1 Missing (Right)

1. Inspect the Spinner. If any of the (8) screws are missing, complete a thorough inspection of the propeller blades, aft fuselage, and tail. As needed, contact ICON for additional support if damage is identified.
2. Torque the (8) spinner screws to 44-46 in-lb.
 - a. **NOTE:** *Fasteners are installed dry.*
