SERVICE BULLETIN

SB-061517 REV C

DATE ISSUED: 6/23/2017
DATE EFFECTIVE: 6/23/2017
SUPERSEDES NOTICE: SB-061517-A/B
SUBJECT: Elevator Control Horn and Push tube rod end jam nut interference and elevator push tube modification
AIRCRAFT AFFECTED: **MODEL:** ICON A5
S/N: 00001, 00003 – 00020
REQUIRED ACTION:
1) Replace elevator push tube with new modified push tube
2) Inspect and correct as necessary light contact/interference between the elevator control horn and elevator push tube jam nut.

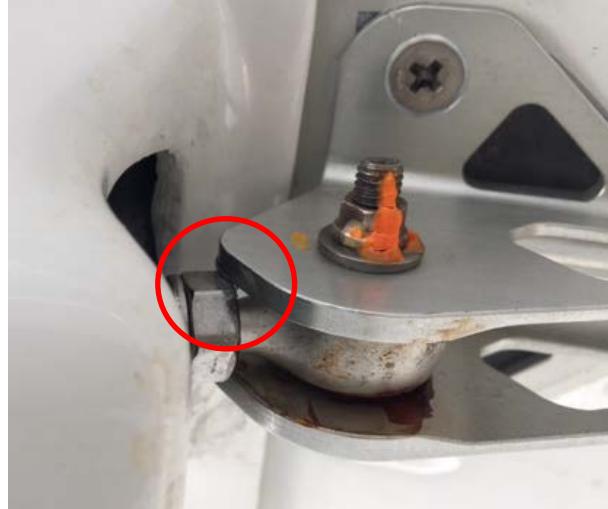
ICON is committed to designing, manufacturing, delivering, and supporting a high quality Light Sport Aircraft, providing a level of safety well beyond expectations. During routine inspection of the aircraft, it was discovered that elevator push tube jam nut contacts the elevator pitch horn during normal range of motion of the elevator example shown in figure 1 and 2. Also, the forked end of the elevator push tube was found out of dimensional tolerancing error. This led to an excessive gap between the end of the elevator push tube and pitch sector bearing and when the rod end bolt was installed, there was an unacceptable preloading condition occurred.

1. Visually inspect the elevator control horn to push rod connection point. If the rod end jam nut contacts the control horn at any time through the range of motion, as shown in Figure 1, replacement of the elevator control horn is required. Figures 2 and 3 show acceptable and unacceptable installations respectively.

Figure 1: Interference between elevator control horn and elevator push rod jam nut

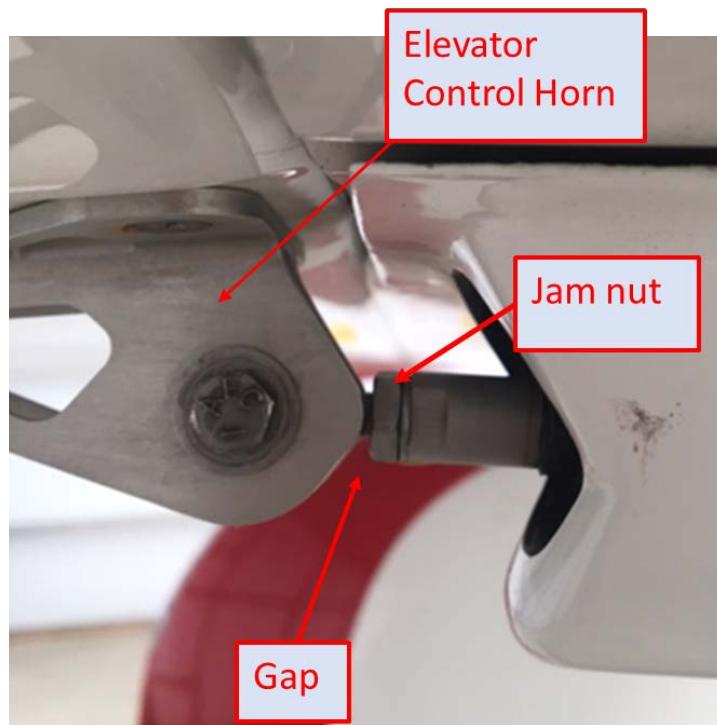
Figure 2: Acceptable installation

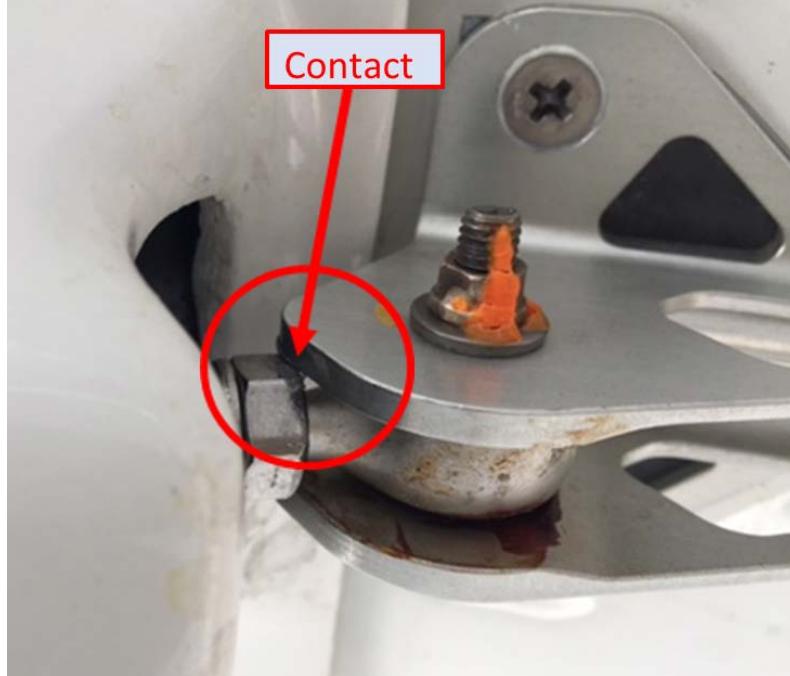
Figure 3: Not acceptable installation
