SERVICE BULLETIN

SB-092917

DATE ISSUED: 9/29/2017
DATE EFFECTIVE: 10/2/2017
SUPERSEDES NOTICE: None
SUBJECT: Forward Roll Pulley Bracket stud inspection
AIRCRAFT AFFECTED: **MODEL:** ICON A5
S/N: ALL

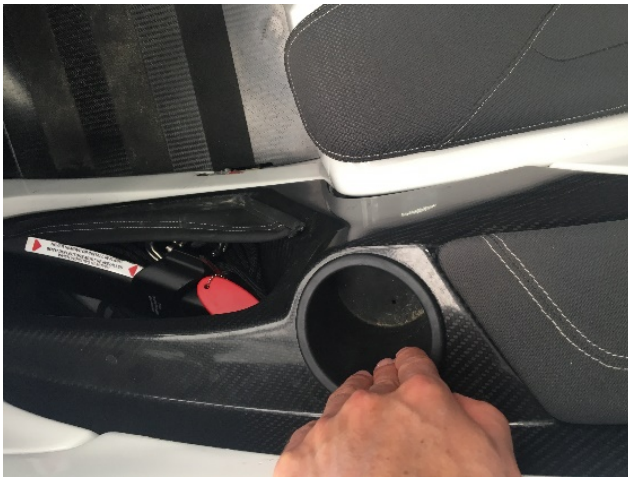
Figure 1: Compress cup holder walls, and lift cup holder out of the main cockpit side panel.

1. Un-Fold the wings (this is required to complete step 4).
2. Remove both cup holders from the main cockpit sidewall panel (Figures 1 and 2).
3. Using a mechanics mirror and flashlight check that both fore and aft retention studs are present with a nut sufficient number of washers (at least one washer present) or carbon shim or aluminum shim present to allow clamping of the bracket to the fuselage skin (figures 3-5). All configurations shown are acceptable if the bracket is clamped to the fuselage skin.

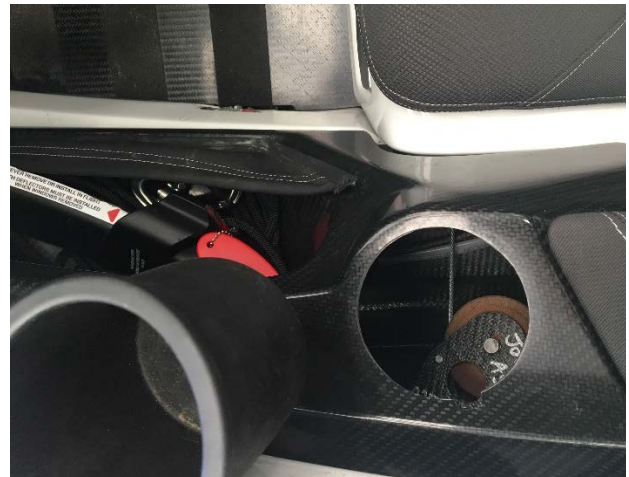
Figure 2: With Cup holder removed the forward roll pulley bracket is visible.

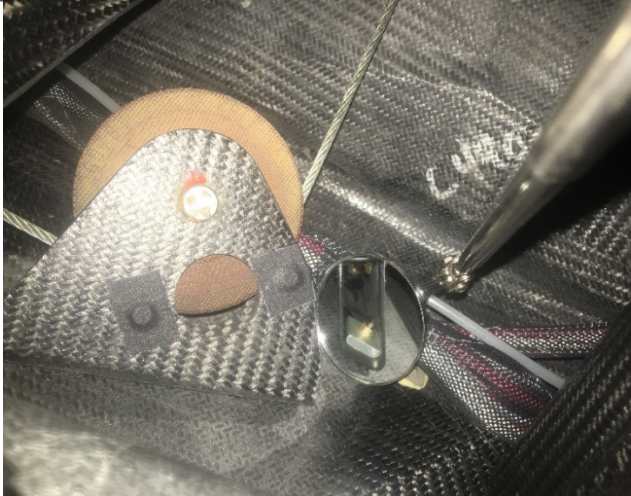
Figure 3: Roll Pulley Bracket Stud with aluminum shim block, and nut. (S/N 00001-00003)

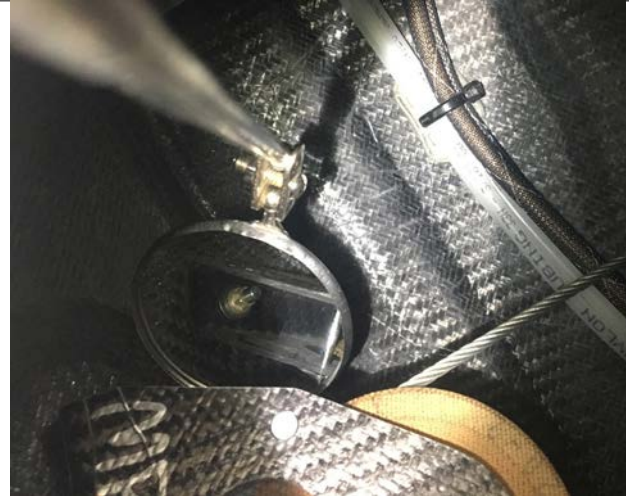
Figure 4: Roll Pulley Bracket Stud with nut and washers only. (S/N 00004-00012)

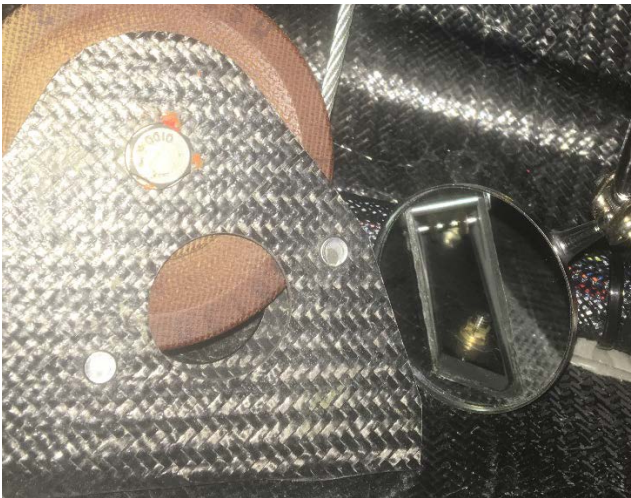
Figure 5: Roll Pulley Bracket Stud with carbon shim, washer and retaining nut. S/N 00013-current)

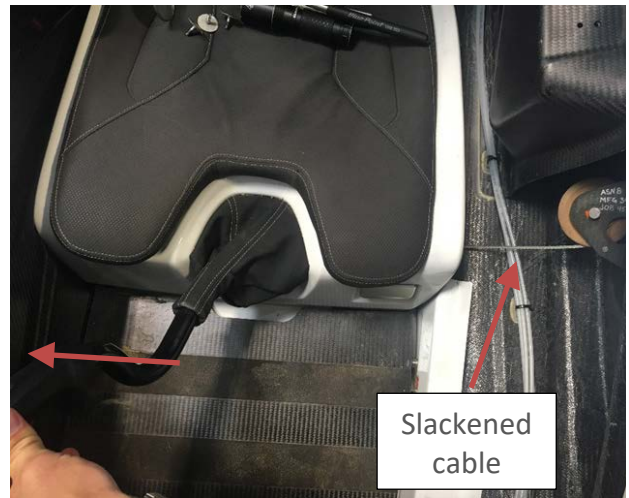
Figure 6: Push stick toward the center console and past the primary lateral stop to slacken the roll cable.

4. Standing outside of the aircraft push the control stick toward the center console past the primary control stop to de-tension lower roll cable enough to offload the bracket. (figure 6)

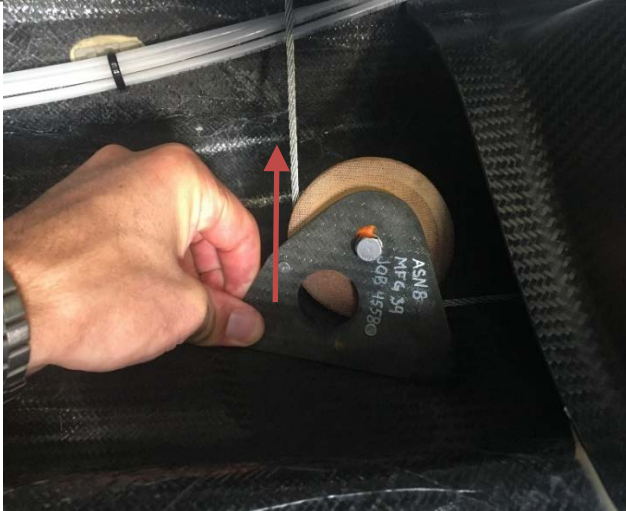
Figure 7: Pull on the bracket away from the fuselage skin wall once the cable is slacked to determine that studs clamp the bracket to the wall.

5. While conducting step 4, use hand pulling forces to pull on the bracket in the same plane as the cable and long side of the bracket in an outward motion from the fuselage skin (figure 7):

- a. If the bracket base lifts off the surface of the skin or is loose in anyway discontinue operation of the aircraft and contact ICON Customer Support for further instruction.

- b. If the bracket is secure, the cup holder can be reinstalled.
6. Repeat steps 3-5 for opposite side.

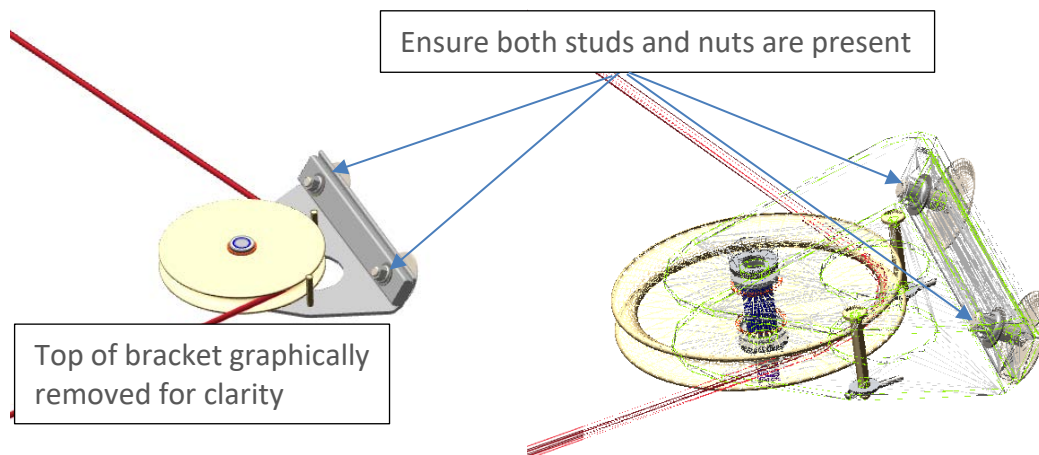
Figure 8: Forward Roll Pulley Bracket Studs.

1. Remove both cup holders from the main cockpit sidewall panel.
2. Reach into the cup holder hole, using one finger feel on the forward and aft side of the forward roll pulley brackets for the presence of both fore and aft roll pulley bracket studs. (figure 8)
 - a. If one of the studs is loose or missing discontinue operation of the aircraft and contact ICON aircraft for further instruction.
 - b. If present and secure re-install the cup holder.
3. Repeat steps 1 and 2 for opposite side.
